TECHNICAL CAPACITY BUILDING OF EXISTING GRAVITY-FED  
RURAL DRINKING WATER SYSTEMS IN HONDURAS

A REPORT

MASTER OF SCIENCE IN CIVIL ENGINEERING

MICHIGAN TECHNOLOGICAL UNIVERSITY

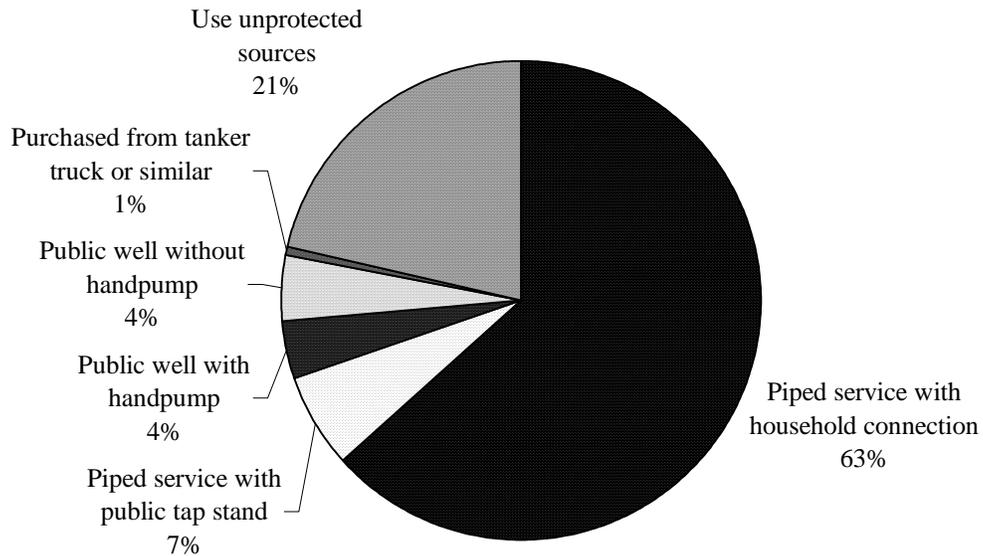
**Figure 2-5: Rural water coverage in Honduras (Trevett 2001)**

The drinking water availability in rural Honduras is improving following countrywide efforts to construct and repair systems damaged by Hurricane Mitch. Figure 2.5 shows the coverage of water services within rural Honduras, indicating that a large percentage of the rural population does in fact have access to potable water. Figure 2.6 shows the compilation of various studies by a number of organizations throughout the 1980's and 1990's. This figure indicates that determining the exact coverage is difficult, but a general pattern of increased coverage can be noticed, with a current coverage of over 80% of the total rural population. It should be noted that approximately 53% of the total population in Honduras is considered rural.

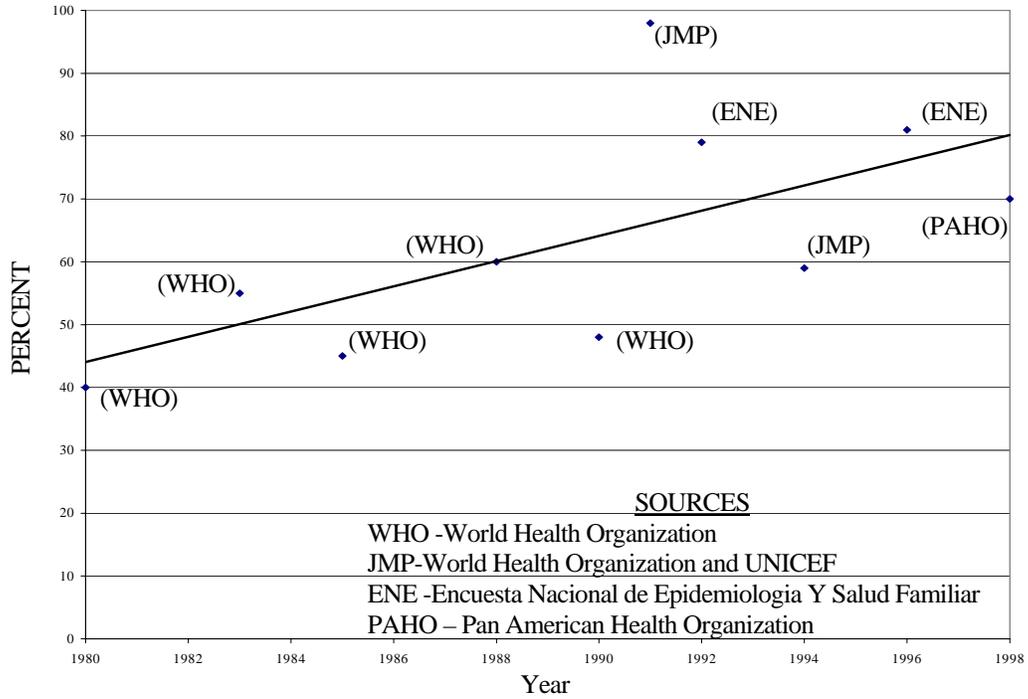
**Figure 2-6: Rural water coverage in Honduras throughout 80' and 90's indicating improved water coverage (WHO 2001)**

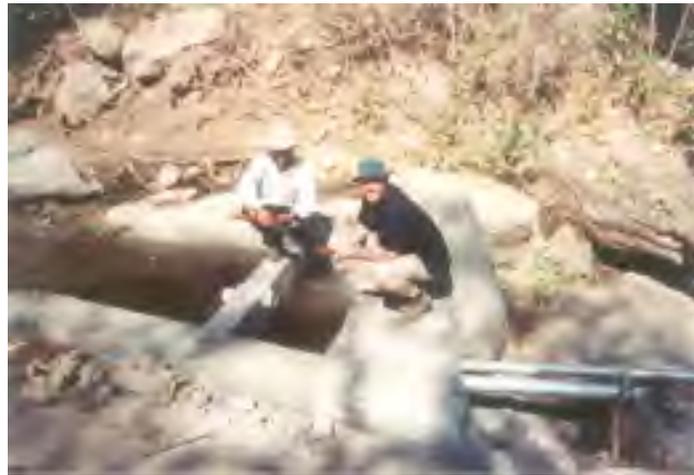
**Figure 3-3: Example of concrete surface-water source with settling chamber for community of 150 houses, feeding a tank of 10,000 gallons, with capacity of tubing to carry 50 gallons per minute. Approximate flow rate of source as shown = 75 gallons per minute.**

Figure 3.3 shows an example of a surface-water catchment structure that also is used as a settling tank. The sediment is trapped in the chamber on the left-hand side as shown in the picture, and the right side chamber is equipped with a cover so no foreign material can enter. The shorter pipe (lower pipe) is opened to allow any sediment to be washed-out, and the longer pipe (upper pipe) carries water to the tank. The overflow can be seen on the left-hand side of the photo. This overflow location allowed for better performance, as only the quantity of water that the tubing could carry would enter the settling tank and box. Any flow over the capacity of the tubing was directed around the structure.

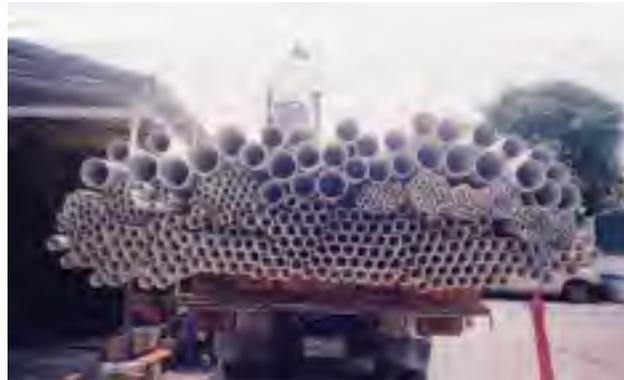
**Figure 3-4: Example of various diameter PVC tubing loaded on truck ready for delivery to 2 separate communities. The 3" and 4" tubing is for a community of 150 houses and the 1 ½" and 1" tubing is for a community of 19 houses. The ½" tubing is for both communities for the connections at each house.**

person per day with the future population given a growth rate of approximately 3.3%. The peaking factor of 1.5 is applied to account for seasonal variation in water demand, as in the dry season more water is needed by the community than in the wet season. PVC (polyvinyl chloride) and GI (galvanized iron) tubes are readily available in the following diameters: ½", 1", 1½", 2", 3", 4". Larger, more expensive tubes are rarely needed in rural water projects. Tubes are sold in 6-meter sections. Figure 3.4 shows a truck loaded and ready for delivery to the community. The larger tubes on top are 3" and 4" tubing for use in the distribution system of a community of 150 houses. Tubing of ½" diameter is located in the middle of the stack on the right hand side for household connections in communities of 150 houses and 19 houses. The majority of the tubing on the lower part of the stack is 1 ½" diameter tubing for use in the conduction line for a community of 19 houses.

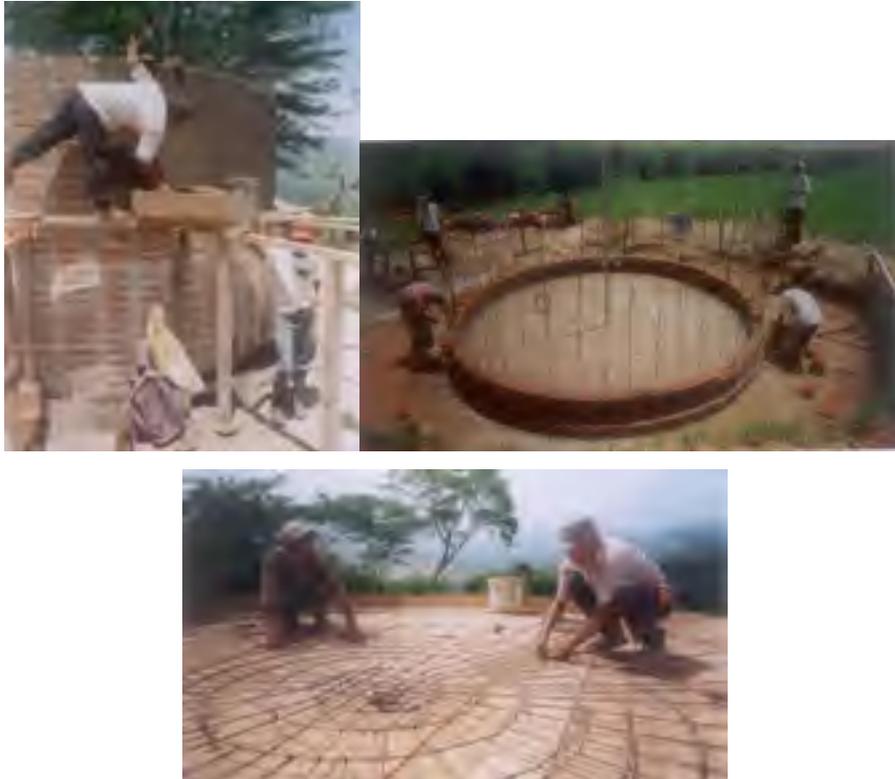
**Figure 3-5: Construction techniques of tank walls and roof for 10,000 gallon tank to serve 150 houses. Upper left photo shows mortar being applied to brick walls, upper right photo shows steel reinforcement in wall, and bottom photo shows steel reinforcement for concrete roof.**

through a non-governmental organization (Action Against Hunger). The designs vary slightly, but they generally all are circular brick tanks, reinforced with rebar in the walls, with a rebar reinforced roof. Figure 3.5 illustrates the construction of a 10,000-gallon tank for a community of 150 houses following the standards of the Honduran governmental water organization. A concrete foundation is built first, followed by construction of rebar reinforced brick walls and finally a rebar reinforced concrete roof.

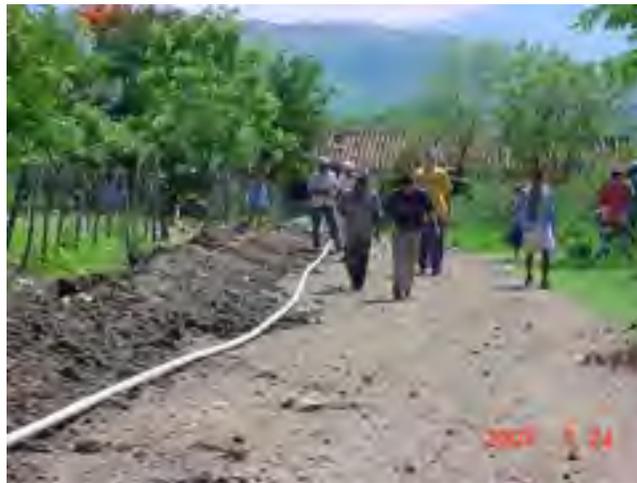
**Figure 3-6: 2” PVC tubing ready to be placed in 3’ deep trench for distribution line in a community of 50 houses.**

(0.018 gallons per minute per person), or 56.5 gallons per person per day (0.039 gallons per minute per person). Figure 3.6 shows an example of a section of a distribution line before being placed in the trench. The distribution line is located on public property to avoid conflicts with permission from landowners. This section of trench (approximately 60 meters) was dug in one day with 6 men, and the tubing was connected in less than one hour.

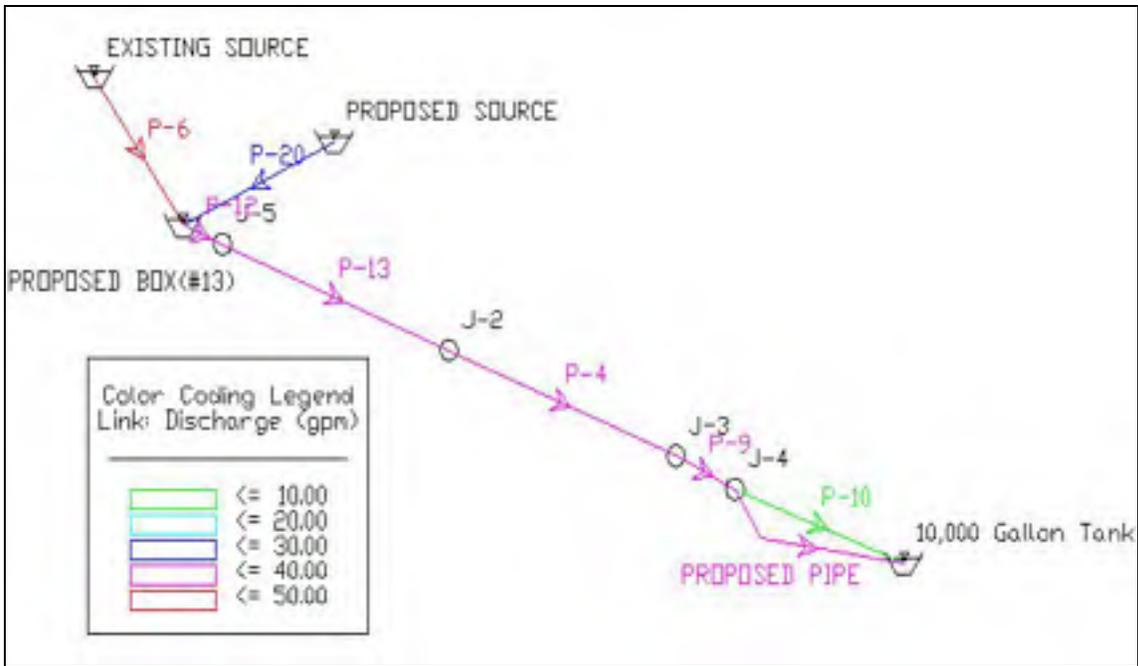
**Figure 4-2 : Schematic of system with new source and use of junction box to unite flows from two sources for a community of 150 houses. An additional pipe was deemed necessary in the lower reaches of the conduction line before the tank to carry the additional flow from the new source, partially due to the junction box acting as a pressure-break tank.**

is located at a higher elevation, the new source may flow directly into the old source. The conduction line should then be analyzed to determine if it has the capacity to carry the extra water if the same conduction line is to be used. Many times the old conduction line will be cut and a collection box will be built to join the two sources, in which all sections of pipe should be sized properly, as shown in Figure 4.2. This figure was generated from a student version of Haestad WaterCAD, a program used to analyze water supply systems. An alternative to the Haestad program is EPANet, which is available at no cost in both English and Spanish. This figure shows a new source with a junction box to be used to join the flows from the two sources. The existing tubing, with the addition of the junction box that also acts as a pressure-break tank, does not have the capacity to carry the combined flow, and a new section of pipe will be used in addition to the existing tubing to carry the combined flow into the tank. This example shows how existing components of a system with new components are used to improve performance.

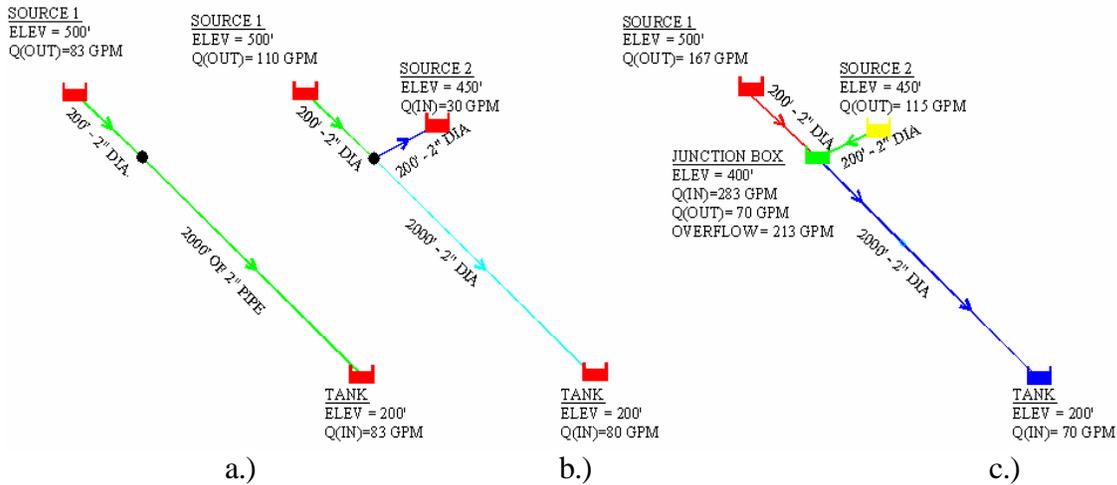
**Figure 4-3: Schematic of addition of source which backflows into new source when joined by a tee**

If the new source is located at a lower elevation, a junction box can be built to join the two sources. The location of the new source may serve as the junction box if local conditions warrant. A junction box will act as a pressure-break tank, and an analysis of the conduction line should be made to ensure the conduction line has the capacity to carry sufficient water to the tank. It is possible to join the two sources with a “T” connection; however the system should be carefully analyzed to ensure that the upper source is not flowing up the tube into the lower source. If the upper source is flowing into the lower source, the tank will receive less water, which will worsen the water situation in the community as is shown in Figure 4.3b where the tank will receive less water than the original configuration shown in Figure 4.3a. The use of a junction box as shown in Figure 4.3c will prevent the backflow situation, however the capacity of the conduction line is decreased from 83 GPM to 70 GPM as the hydraulic grade line is shifted down to the elevation of the junction box. The construction of a junction box assures that both sources are contributing.

If the size and length of the tubing are shown in figure 4.4 (1" pipes from source to box compared to 2" pipe in figure 4.3), then the use of a "T" will prove to be beneficial and there will not be any backflow of water up into the new source. Figure 4.4b shows that water will flow from the new source to the tank, improving performance. Figure 4.4c shows that joining the two sources with a junction box will ensure that water flows from both sources. The use of a junction box in Figure 4.4c in fact increased the carrying capacity of the tube entering the tank when compared to the original shown in Figure 4.4a. This result is not always the case, which shows a careful analysis when adding a source must always occur. The additional capacity is due to the fact that the hydraulic grade line in the original system at the point of the junction box was below the elevation of the future junction box. This upward shift in the hydraulic grade line can also be noticed in the decrease in water flowing out of Source 1. Originally, the source supplied 42 GPM (Figure 4.4a), but with the hydraulic grade line being forced *up* to the elevation of the ground, the quantity of water from the original source lowered from 42 GPM to 27 GPM and the capacity of the tube entering the tank increased from 42 GPM to 70 GPM. There will only be 46 GPM of water entering the tank due to the capacity of the lines from the two sources to the junction box does not supply the maximum 70 GPM.

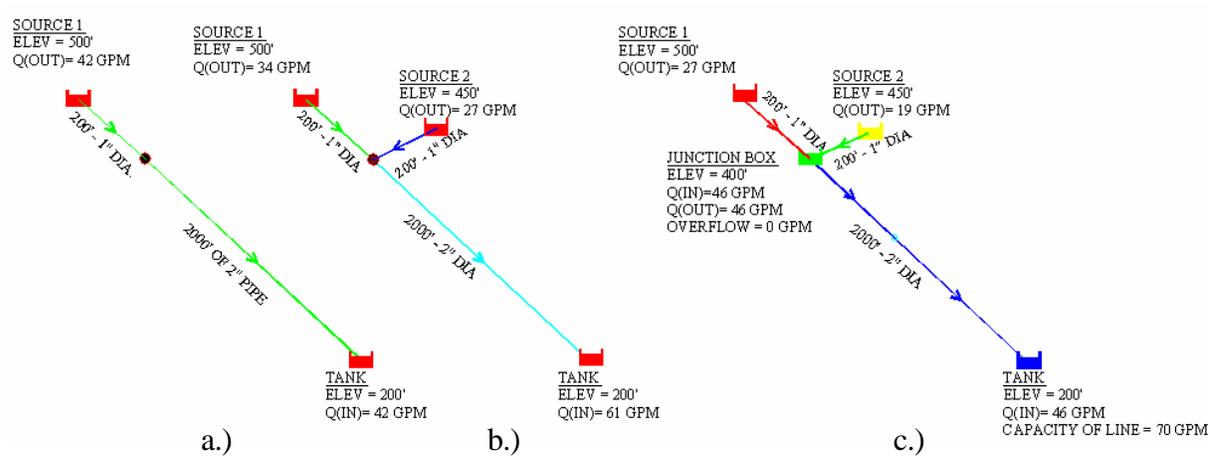
**Figure 4-4: Schematic of additional source showing a.) original conditions b.) additional source flowing to a tee c.) use of junction box to unite flows**

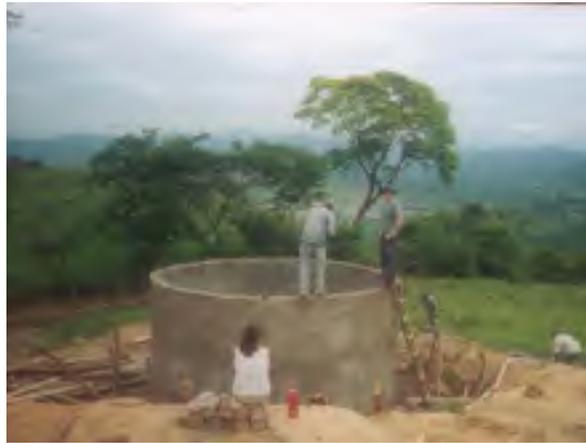
**Figure 4-5: Construction of 10,000-gallon tank for community of 150 houses**

Tank size does not change pressures within the conduction line or distribution line. Figure 4.5 shows an example of a 10,000 gallon tank for a community of approximately 150 houses. This tank was located approximately 30 meters above the highest house and 120 meters above the lowest house. The tank elevation and the level of the water affect pressures. A larger tank may store wasted water, therefore allowing more water to be available during peak hours. It is common to see a tank where the outflow of the tank exceeds the inflow of the tank for a long

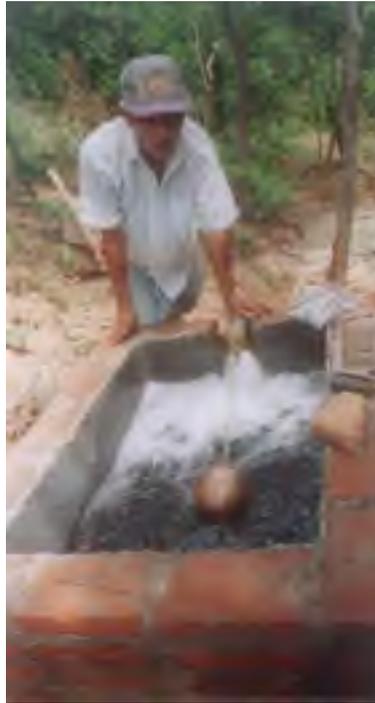
**Figure 4-8: Pressure-break tank with 2” diameter float valve with valve currently open due to demand by houses downstream from pressure-break tank.**

A common problem encountered may be a pressure-break tank with a faulty float valve. A pressure-break tank is designed to shutoff when full. Figure 4.8 shows a pressure-break tank in the distribution line of a community serving 150 houses with a 2" diameter entrance and 3" diameter exit. The tank as shown is filling and houses downstream are using water. Once all houses downstream close their valves, the tank will fill, raising the float and closing the valve, allowing for increased pressures upstream. The large storage tank will then start to fill as all the houses close their valves. However, if water continues to enter the pressure-break tank when in a full state due to a faulty valve, water is lost in the overflow tube of the pressure-break tank and the storage tank may never fill. For this reason, it is best to always try to minimize the number of pressure-break tanks in the distribution line, or eliminate them completely. Pressure restraints (typically 60 – 80 psi), however, should be maintained as close as possible because valves and accessories are more susceptible to problems under high pressure. The permissible strength of the tubing usually exceeds the required pressure to cause failure of the accessories, depending on the type of tubing purchased. The elimination of pressure break tanks can only occur by carefully locating the storage tank at the lowest elevation possible while providing a minimum of 15 pounds per square inch (psi) of pressure to all houses. Locating the tank occurs in the initial design phase, in which case an engineer

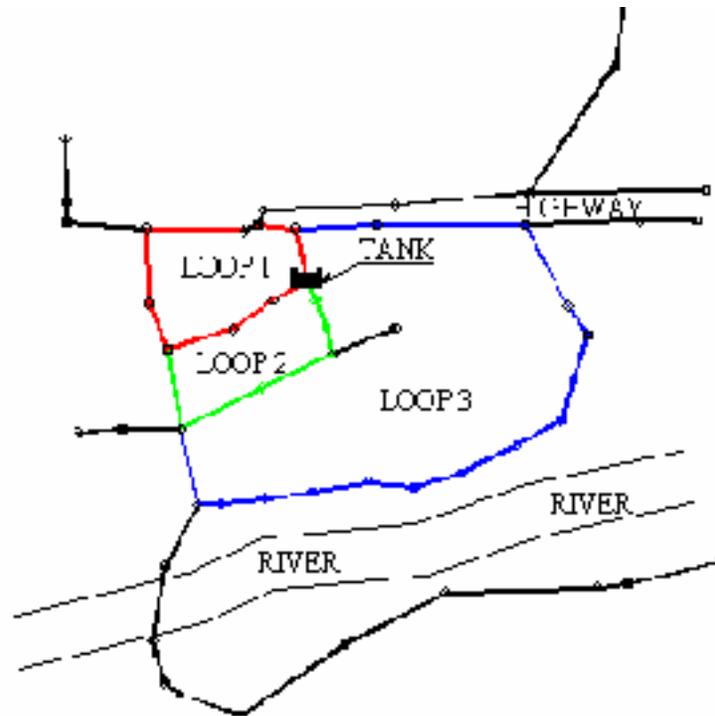
**Figure 4-9: Planimetric view of system with 3 loops for community of 70 houses, providing multiple paths for water to arrive to many sections of the community. All tubing is of 2" diameter for ease of construction.**

Using creative solutions to install the tubing can improve pressure. Looping a system, or creating multiple paths for the water to flow will decrease the losses in pipes as the flow rate in an individual pipe will be decreased if two pipes are supplying a certain section. See Figure 4.9 for an example of a looped system, in which the water has multiple paths to arrive at the houses. This system has 3 loops, giving multiple paths for the water to arrive to each section of the community. This decrease in the quantity of water flowing through each tube decreases the frictional losses, leading to improved pressures. The drawback to looping a system is more control valves are required in order to have full control of the system (closing sections for maintenance). More powerful software programs such as EPANet or Haestad WaterCAD are used to determine expected pressures. The Excel program used by Peace Corps Volunteers in Honduras does not have the capacity to determine pressures when a closed circuit is encountered. See Reents (2003) for more information regarding the program used by Peace Corps Volunteers in Honduras.

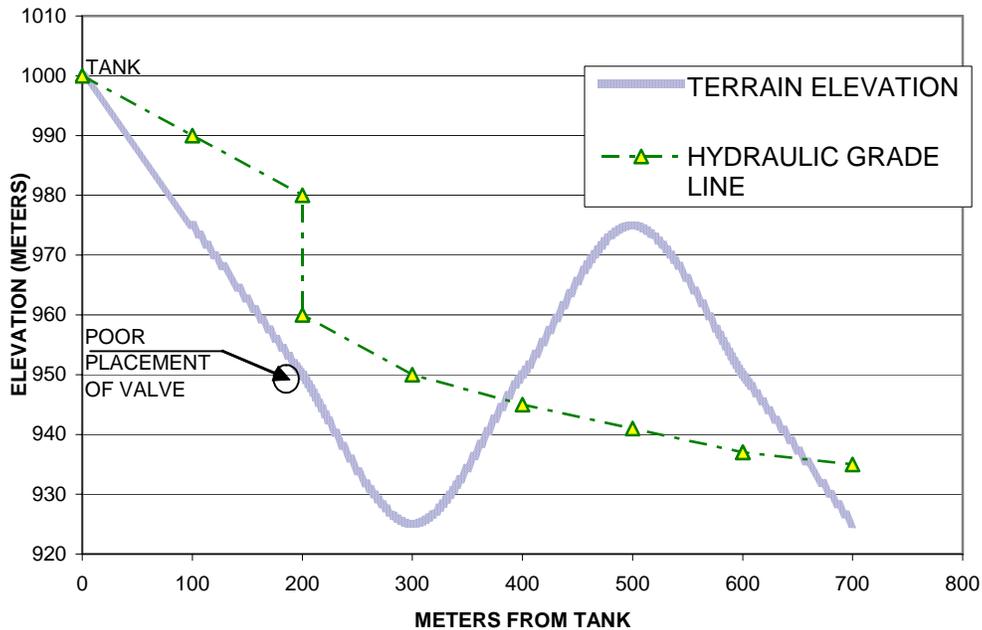
**Figure 4-10: Example of poor placement of control valve in rural water system showing negative pressures in higher reaches due to losses created by control valve**

The use of control valves can help in cases in which lower houses receive water and the higher houses do not. The topography and system layout is very important and must be evaluated in the consideration of valves. For a system in which the higher section of houses is located farther from the tank than the lower houses, a control valve installed on the mainline will not accomplish the goal of raising the hydraulic grade line in the upper section (see figure 4.10). Only in the situation where the lower houses are located farther from the tank than the higher houses should a control valve be used.

A control valve will create large losses, or completely shutoff the flow of water to lower houses in order to deliver water to the higher houses. However, with a correctly operating system, all lower houses should close valves when not in use, in which case a control valve is not necessary. This concept is closely related to community education and emphasizing to those who live in lower houses the importance of careful water management.
